Analyzing Quality Control Aspects in an on Going Construction Projects with Respect to Cost and Time

Lalithya.V¹, Indhu.B²

¹Department of Civil Engineering, S.R.M University, Chennai, India, vlalithyanaiducivil@gmail.com

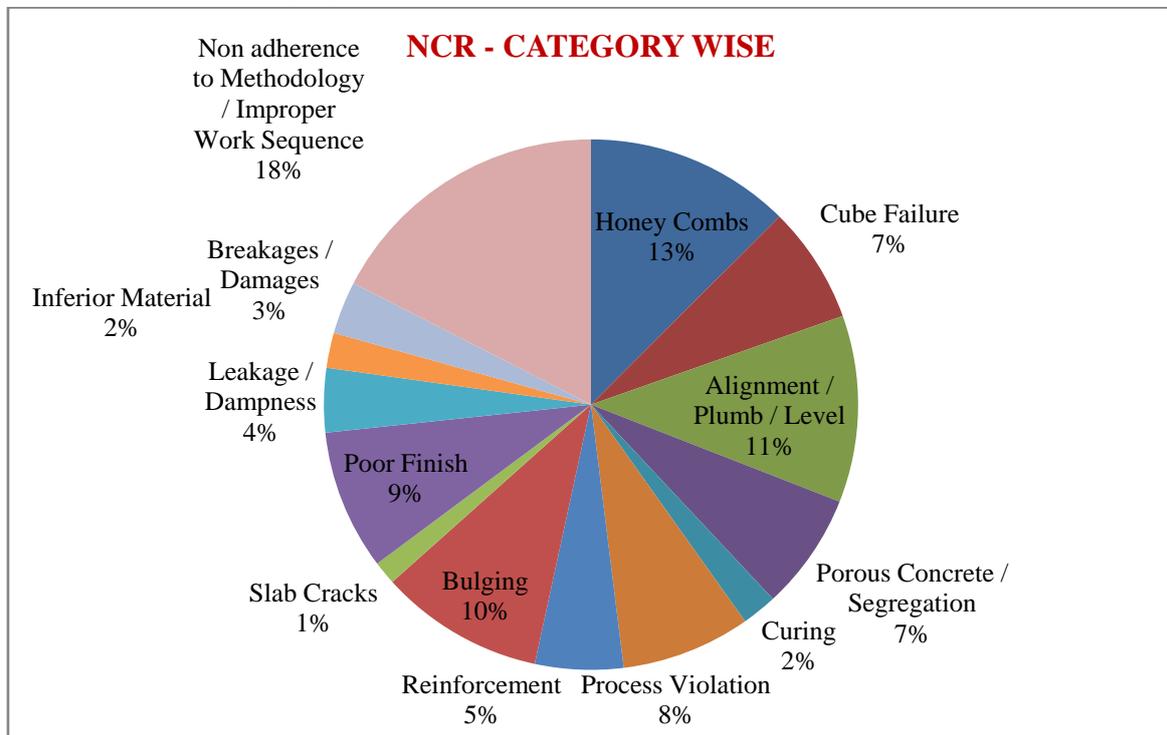
Category	No's
Honey Combs	35
Cube Failure	20
Alignment / Plumb / Level	32
Porous Concrete / Segregation	20
Curing	6
Process Violation	22
Reinforcement	15
Bulging	28
Slab Cracks	4
Poor Finish	24
Leakage / Dampness	11
Inferior Material	8
Breakages / Damages	9
Non adherence to Methodology / Improper Work Sequence	47
Total	281

Figure1. Showing Percent of Non-conformances in Each Category

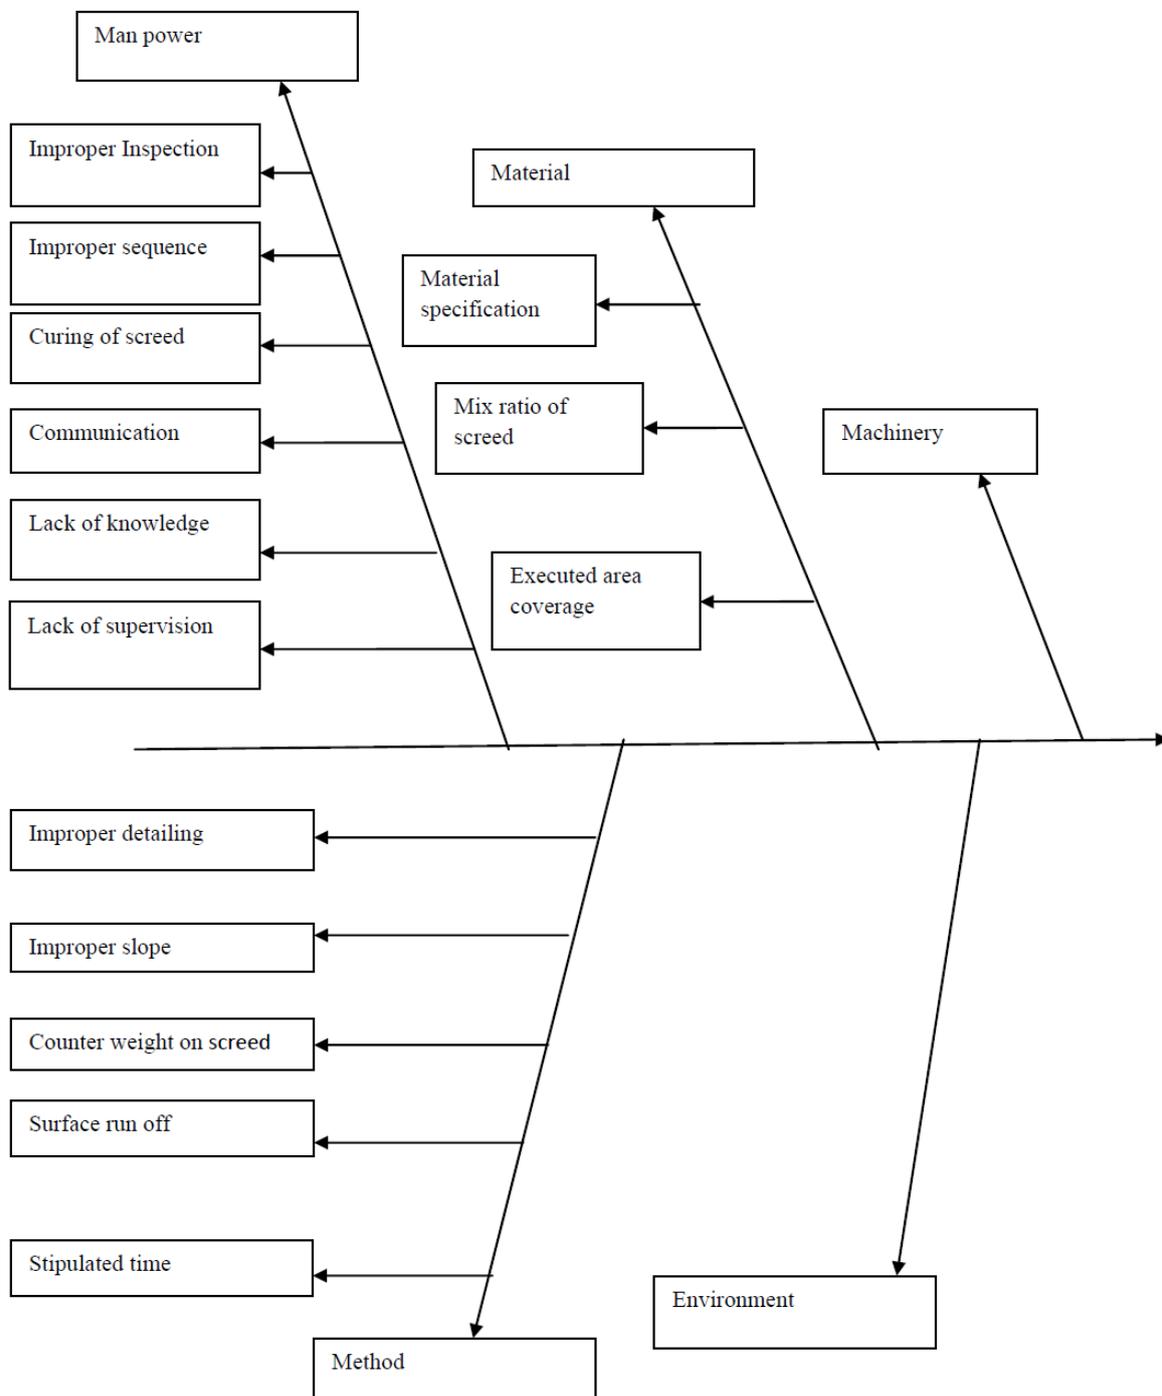
The Hollowness in top screed led to water stagnation at some location on roof top. Cracks and dampness are observed on the roof slab in top screed due to water stagnation. This problem is solved by using Cause and Effect Model.

Possible causes for the water stagnation, cracks, and dampness are made using cause and effect model by Brainstorming and discussions. The causes identified are based on lack of skilled labor, poor materials and improper methods followed during construction process.

Figure2. Cause & Effect Diagram

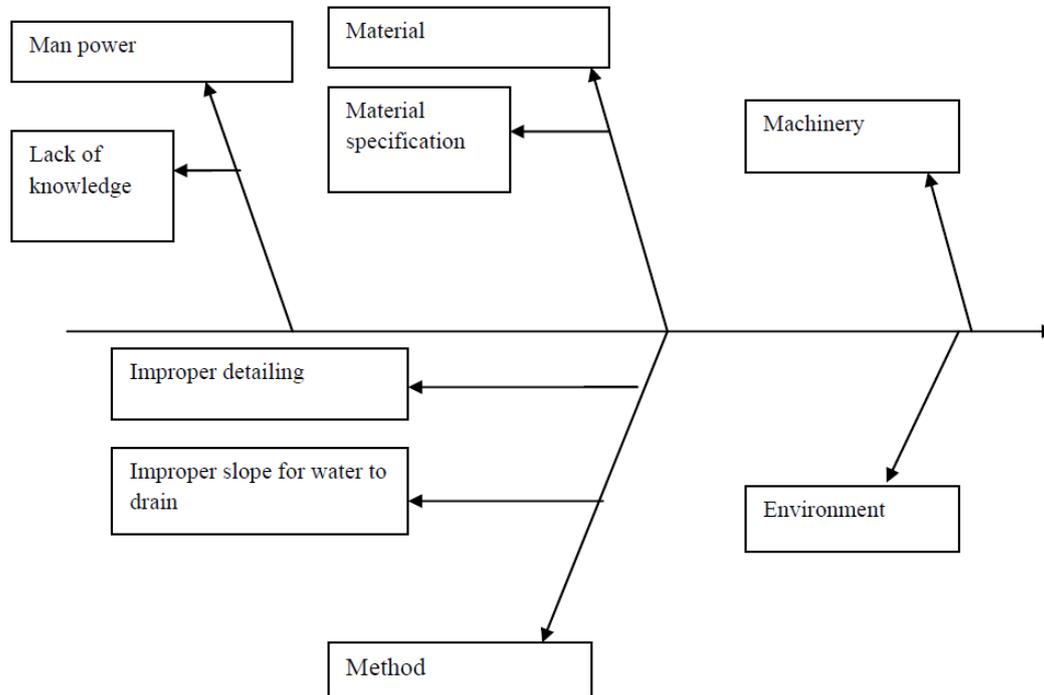
Sr. No.	Probable causes	Classification
1	Improper detailing	Method
2	Improper slope for water drain	Method
3	Lack of knowledge	Man
4	Material specification	Material

Thus these are all the relevant brainstormed causes identified after elimination and are shown in figure below.

Figure2. Shows Cause & Effect Diagram

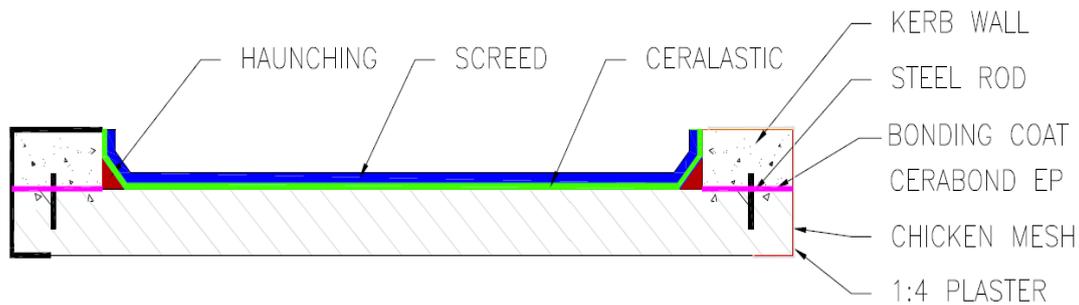
Figure3. Showing Remedy Diagram

Finally Kerb of 100mm x 100mm is done on the periphery of roof slab avoiding the surface drain and also to have proper end detail for waterproofing and also the plaster and screed are shown in figure below helped to avoid cracks. This improvement made through standard methodologies helped to rectify the cracks and dampness on the top roof.

Effort is taken to rectify the Non-conformance by effective team coordination and improving slope of slab which was previously 1:200 to maintain the aesthetically sleek slab is now rectified to 1: 100 and even the material specification is now selected properly with respect to climatic conditions. Kerb of 100mm x 100mm is done on the periphery of roof slab avoiding the surface drain.
