## Full Scale Testing of Fire Performance on A House Construction System Assembled With Sandwich Steel and Polyurethane Structural Panels

Luciani Somensi Lorenzi; Kássio Joe Stein; Luiz Carlos Pinto da Silva Filho.

Universidade Federal do Rio Grande do Sul, Laboratório de Ensaios e Modelos Estruturais (LEME), Avenida Bento Gonçalves, CEP 91509-900 - Porto Alegre, RS, Brasil.

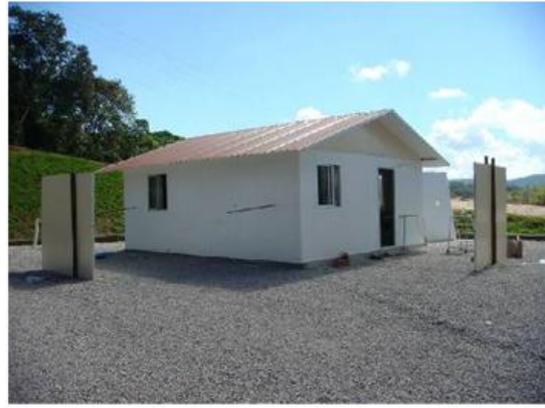
**Fig1.** General view of the prototype.

Three barriers were built 3 m away from the outside walls of the prototype, with the objective of providing protection to the team collecting data, and to simulate the presence of neighboring buildings.

The barriers were constructed with the same material of the prototypes and instrumented to collect data about the levels of temperature at the surface of neighboring buildings as illustrated in Figure 1.

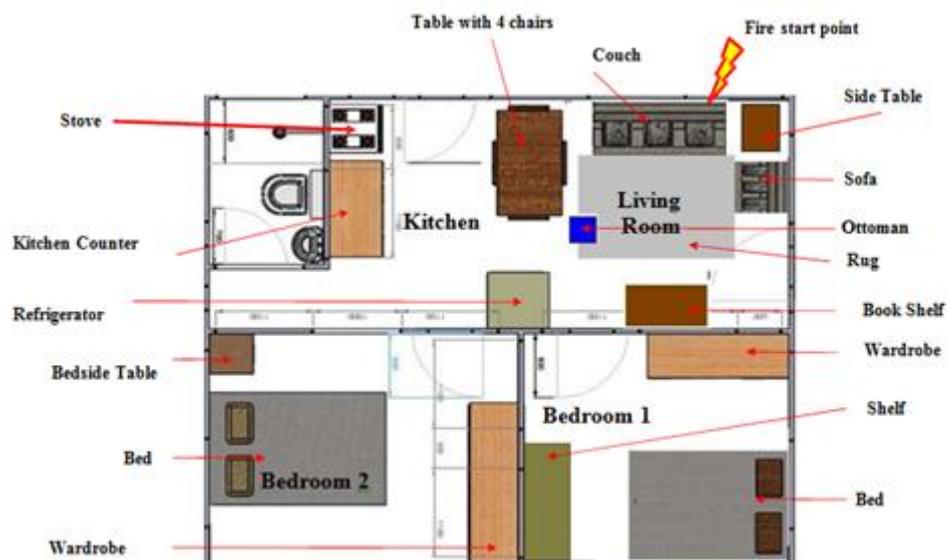
**Fig2.** Fire load distribution in the prototype and fire start point location.

The prototype fit Class A-1 according to the Table B.1 of ABNT NBR 14432 [2] and required a fire load of 300 MJ/m<sup>2</sup> according to Table C.1 of the same Brazilian code. The furniture placed in the prototype resulted in a fire load of 306.37 MJ/m<sup>2</sup>. This fire load was chosen according to the Table 1 and distributed according to the Figure 2.

The starting point of the fire was chosen with the help of the Fire Department, which experience indicated that most unintentional fires in Brazil start in the common areas of the houses or in the bedrooms, and not in the kitchen area as many assume. The statistics of the Fire Department [13] indicate that one of the most common causes of fire in Brazil are candles left unattended. Based on this information, the ignition point was positioned in the living room area and it was defined as a lit candle on the couch, as shown Figure 2.

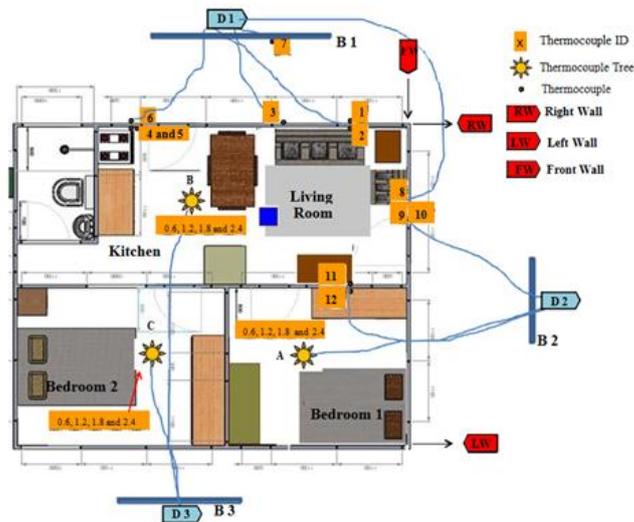
**Fig3.** Thermocouple and measuring station locations.

Twelve thermocouples were positioned as three trees that measured the heat in different heights; one tree located in each of the prototype's extended-stay rooms (kitchen and bedrooms).

The heights of each thermocouple located in each tree were 0.6, 1.20, 1.80, and 2.20m, and each tree was able to record 12 temperature measurements. The other thermocouples were placed on the internal and external surfaces of the wall and one was placed at the window closer to the start point of the fire. An accurate scheme of the placement of each thermocouple can be seen in Figure 3.

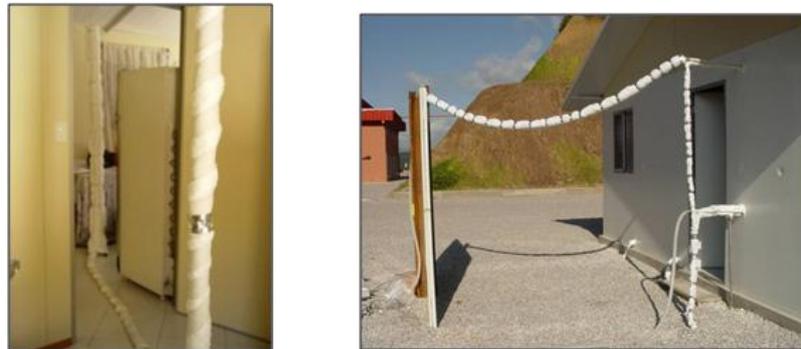
**Fig4.** Instrumentation - (a) gas collectors located close to the B2 barrier; (b) thermocouple trees inside the prototype.

An example of the thermocouple trees can be seen in Figure 4b, which shows an internal view

of the prototype with the thermocouple trees C (front) and B (back) in display.

The five internal gas collectors were metallic or ceramic tubes connected to suction bombs used for aspirating the gases, the locations of these collectors is shown in Figure 5 and an example

of them can be seen in Figure 4a. Three external gas collections were also placed near the B1, B2 and B3 barriers.

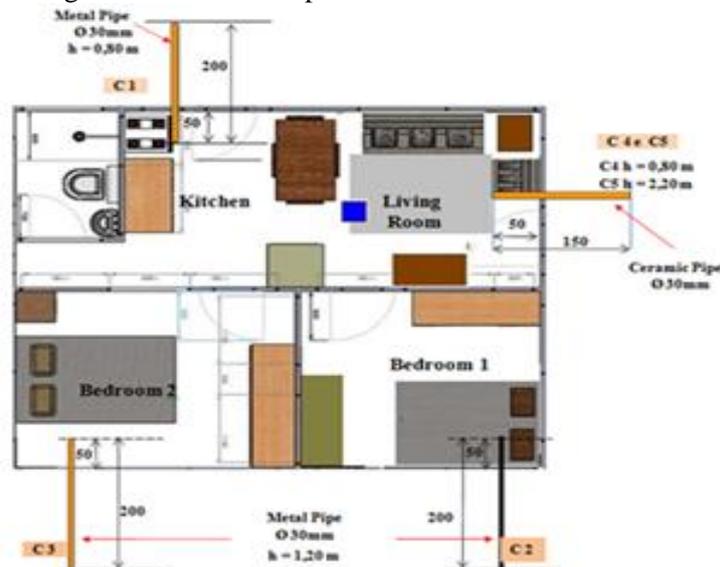
**Fig5.** Distribution and location of gas collectors.

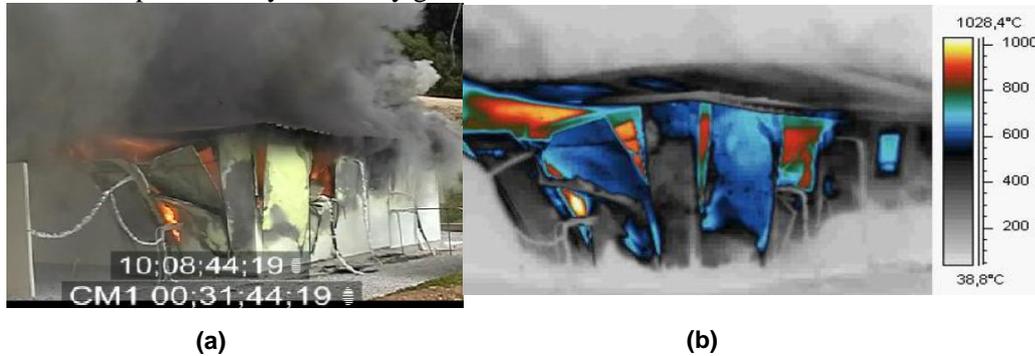
**Fig6.** Prototype after collapse: (a) camcorder view e (b) thermograph view.

The time of the end of the test was 10:08 a.m. and it was characterized by the collapse of the structure, 31 minutes after starting the test. Images of this moment are shown in Figure 6. During the test, some important events that occurred must be described. The wind registered on the day of the test was from north and northeast with speeds ranging from 4.0 to 6.0 m/s. The wind affected directly the results of the test, since the smoke generated by the fire was carried to the south side of the prototype (close to the B3 barrier). Visible flames decreased and the fire seemed too died out 6 minutes after the beginning of the test. The data indicates that at

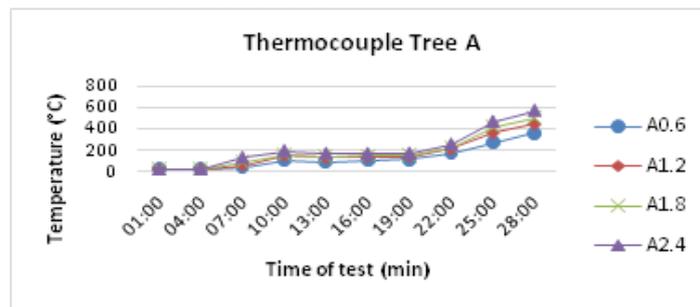
**Fig7.** Temperatures collected by the thermocouple tree A.

Internal temperatures were also monitored throughout the test, with data collected at every second from the start of the test until 28 minutes later, when the data loggers and computers were removed to prevent damage. The temperatures in each of the thermocouple trees during the test can be observed in Figures 7, 8, and 9.

At the beginning of the test, the average temperature assessed from the twelve thermocouples positioned at the center of each of the extended-stay rooms was 22°C. Approximately seven minutes after the start of the ignition process, the temperature in the living room/kitchen (tree B) was about 230% higher than the average temperatures measured in bedrooms 1 and 2, located 1.20 m away. Throughout the test, the higher the thermocouple was positioned, the higher was the temperature recorded, as expected. The temperatures recorded by the thermocouple tree B, located in the kitchen/living room showed that the temperature of 900°C was reached by every functional thermocouple by the end of the test, regardless of the height of the sensors. The internal thermocouples, located in different

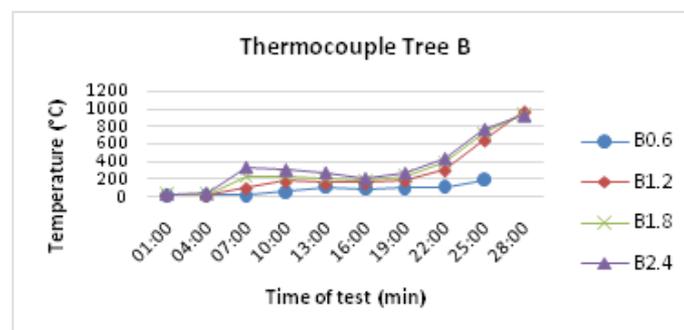
**Fig8.** Temperatures collected by the thermocouple tree B.

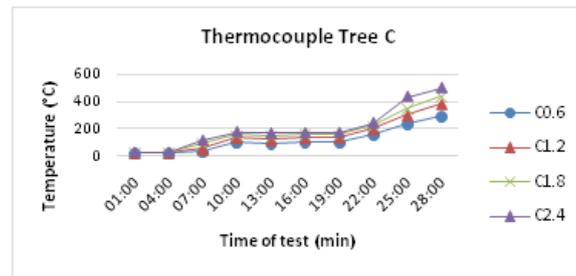
Fig9. Temperatures collected by the thermocouple tree C.

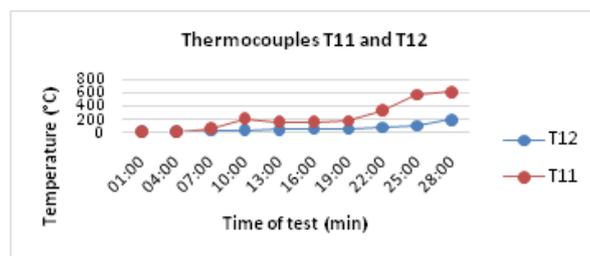
Fig10. Different temperatures on each side of the sandwich panel for the living room and bedroom 1.

rooms, showed considerably different temperatures, and their measurements are shown in Figure 10. The thermocouple T11, located on the side of the panel that faced the fire, 7 minutes after the start of the test, registered 79°C. At the same time, the temperature of the thermocouple T12, located on the side of the panel that faced the bedroom 1, was only 27°C, showing a difference of 48°C between the two sides of the panel. The highest temperature difference between the two sides of this panel was registered 24min22sec after the start of the test. It happened at the moment when the side of the panel that was exposed to the fire was at 612° C and the non-exposed side of it was at 113°C. At this point, the furniture inside bedroom 1 started to ignite, and increased the temperature even more.

The difference of temperatures between external wall tiles was measured by the thermocouples T1 and T2 located on the kitchen door, and showed a considerably lower temperature on the external side of the wall panel, as can be observed in Figure 10. The same behavior was noticed near the fire source by the thermocouples T1 and T2, as shown in Figure 11.

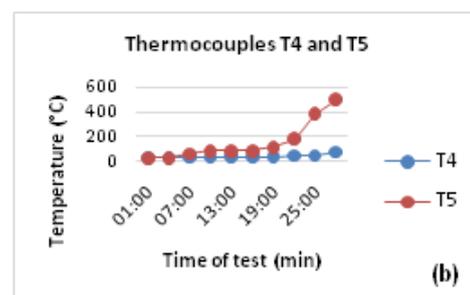
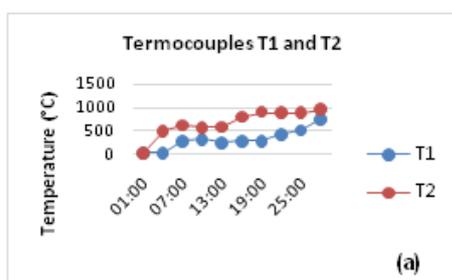
Fig11. Different temperatures on each side of the sandwich panel for: (a) the living room and external area; (b) the kitchen and external area.

The last location chosen for this type of measurement was close to the fire source with the thermocouples T9 and T10. This reading point was lost, since the thermocouple T9 malfunctioned at the beginning of the test.

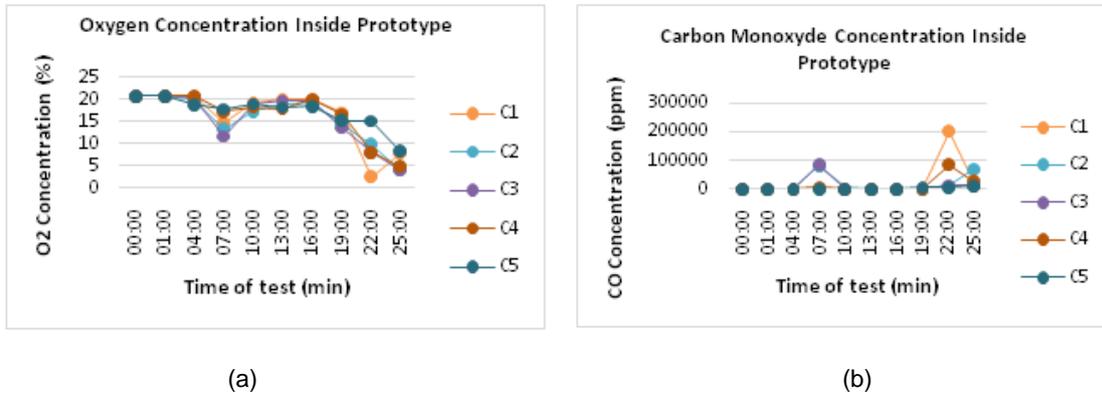
**Fig12.** (a) Oxygen concentration decrease inside prototype; (b) Carbon Monoxide concentration increase inside prototype.

samples of gas from inside the prototype were collected and analyzed. Figure 12 shows carbon monoxide and oxygen concentrations for each environment: C1 (Kitchen), C2 (Bedroom 1), C3 (Bedroom 2), C4 (Living Room), C5 (Living Room).

Due to budget constraints, data collection focused on concentration of CO and O<sup>2</sup> gases (HCN concentration analyses were not performed). For the first two samples, the temperatures were mild and the gas concentrations were very low, compatible with human survival. From the 3<sup>rd</sup> collection (4 minutes from the start of the test) onwards, we observed that carbon monoxide (CO) concentration increased significantly. The concentrations of remaining oxygen (O<sup>2</sup>) were above 20%, and the temperatures remained mild. The temperature at collection point C5, which increased to 49°C, was an exception of it. After 7 minutes (4<sup>th</sup> data collection), high concentrations of CO were detected, especially in C2 (Bedroom 1) and C3 (Bedroom 2), with peaks of 83,500 ppm and 84,000 ppm, respectively. The concentration of O<sup>2</sup> dropped significantly to 17.8%, and the temperatures increased significantly, with a record of 400°C on C5. These conditions threaten human

survival and can be explained by the volatilization of PU from the roof panels that occurred at 06:30 minutes of the test. This fact was crucial for the quick auto-ignition process of the furniture inside the prototype, since the high temperature of the gases released caused a generalized increase in temperature.

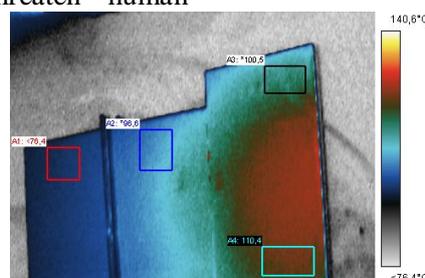
**Fig13.** Thermographic image of barrier B1 18min after test start.

The temperatures recorded on the B1 barrier, used to simulate a neighboring building, were around 36°C at the beginning of the test, and progressed to 46°C after 29:18 minutes of test (time of last reading, since the measuring device was removed before collapse to prevent damage). Thermographic records of B1 barrier are shown in Figure 13. These thermographic readings indicate the existence of radiating temperatures higher than those measured by the thermocouple T7, located on the surface of the B1 barrier.

Nine minutes after the collapse of the prototype, the temperature registered by the thermograph

near the B1 barrier was around 246°C, while the debris of the prototype measured 1120°C.

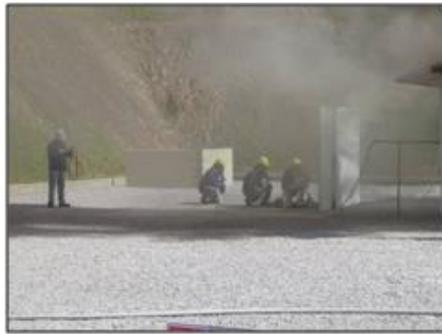
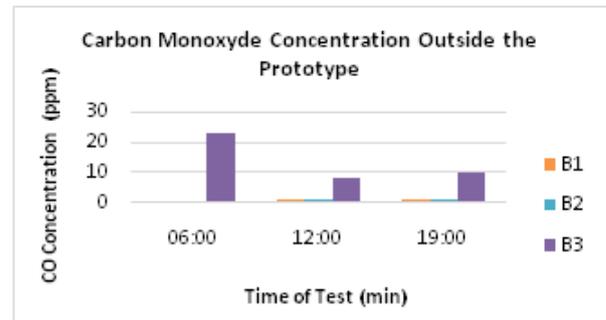
**Fig14.** (a) Collection of external gases near the barrier B3; (b) Concentration of carbon monoxide at external environment.

Gas collection outside the prototype was performed via suction devices, and used to evaluate the effect on the neighborhood. The

collection was performed by technicians protected by the barriers in 6-minute intervals, as shown in Figure 14.

In the three samples, the oxygen concentration remained relatively stable and above 20%. Carbon monoxide presented a small variation and its maximum concentration was recorded during the third collection at the B1 barrier (23 ppm). These concentrations do not endanger the neighborhood.
